Seal Strength Profile and Sealed Package Vacuum Decay Testing

**Customer
Name
1/1/2023**

Date	January 1, 2023
Customer Name	Customer Name
Address	123 Main St, Anytown OH, 12345
Contact	Customer Contact Info
Lako Technician	Technician Name
Lako Contact	+1 (419) 662-5256 7400 Ponderosa Rd, Perrysburg, OH 43552
Project Number	FT-23-0XX
Lako Estimate Number	12345
Customer PO	12345

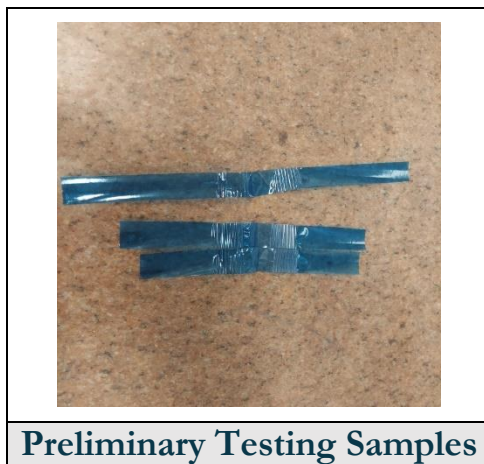
Material	Temperature	Observations
Film 1	200° F [93° C]	Film did not seal fully
	250° F [121° C]	Film sealed with no distortions
	300° F [149° C]	Film melted

Based on observations from the preliminary testing, the recommended temperature range for Seal Strength Profile Testing is **190° F to 280° F** [88° C to 138° C].

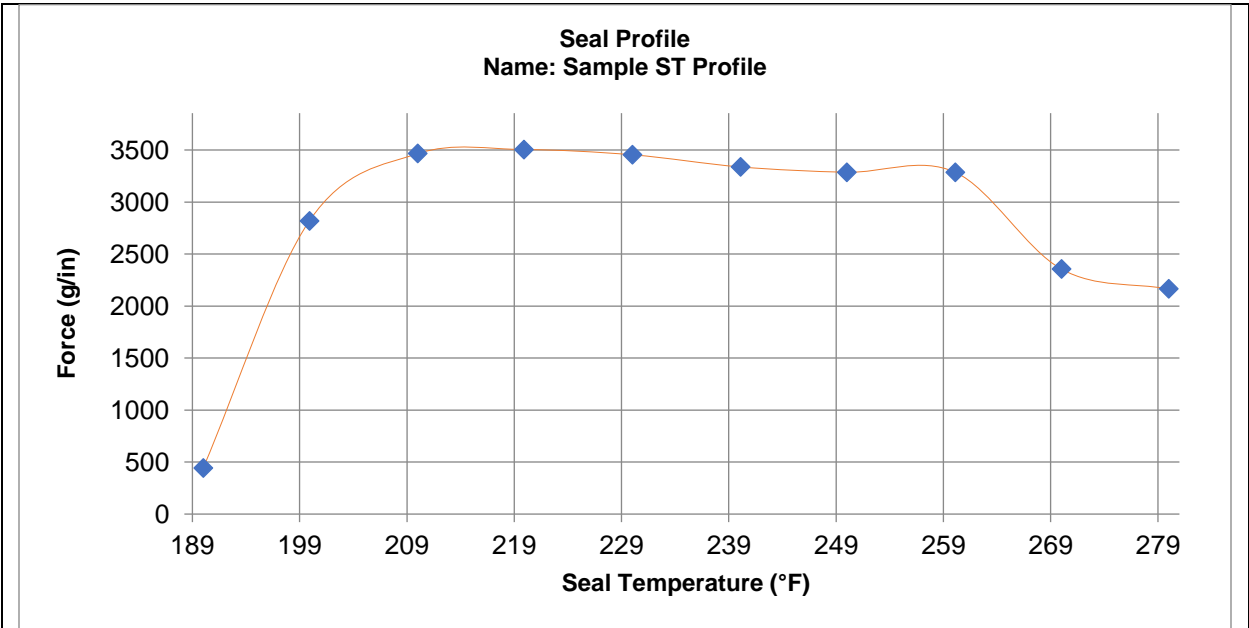
Ultimate Seal Strength Test Results

Title:	Sample Test	Name:	Est 12345 FT-01-023 Sample Test
Machine S/N:	SL10S131102	Date:	01/01/2023 12:00:00 AM
Laboratory Temp:	74°F [23.3°C]	Operator:	XXX
Laboratory Humidity:	45%	Material:	Clear Film 0.003"
Upper Starting Temp:	190.0 °F [88° C]	Lower Starting Temp:	190.0 °F [88° C]
Upper Ending Temp:	280.0 °F [138° C]	Lower Ending Temp:	280.0 °F [138° C]
Seal Length:	1.000 in	Pressure Request:	40.0 PSI
Seal Width:	0.375 in	Jaw Pattern:	Steel Upper/ Steel Lower
Dwell Time:	0.500 sec	Peel Velocity:	0.20 in/sec
Cool Delay:	20.00 sec	Selection Method:	Peak

Seal testing was performed to find the temperature range with the highest Hot Tack strength and Ultimate Seal Strength. The Ultimate Seal Strength consistently increased with the increasing temperature, while the Hot Tack Strength was highest between 265° F [129.4° C] and 295° F [146.1° C].

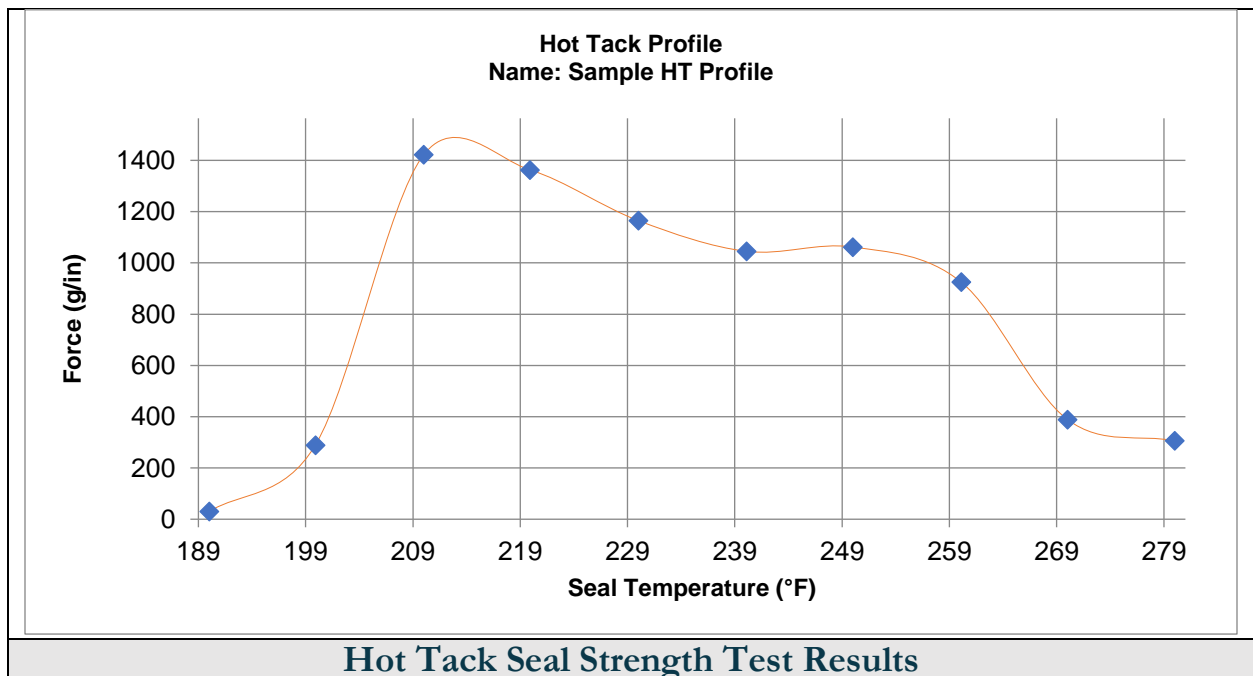
Title:	Sample Test	Name:	Est 12345 FT-01-023 Sample Test
Machine S/N:	SL10S131102	Date:	01/01/2023 12:00:00 AM
Laboratory Temp:	74°F [23.3°C]	Operator:	XXX
Laboratory Humidity:	45%	Material:	Clear Film 0.003"
Upper Starting Temp:	190.0 °F [88° C]	Lower Starting Temp:	190.0 °F [88° C]
Upper Ending Temp:	280.0 °F [138° C]	Lower Ending Temp:	280.0 °F [138° C]
Seal Length:	1.000 in	Pressure Request:	40.0 PSI
Seal Width:	0.375 in	Jaw Pattern:	Steel Upper/ Steel Lower
Dwell Time:	0.500 sec	Peel Velocity:	0.20 in/sec
Cool Delay:	Immediate	Selection Method:	Peak

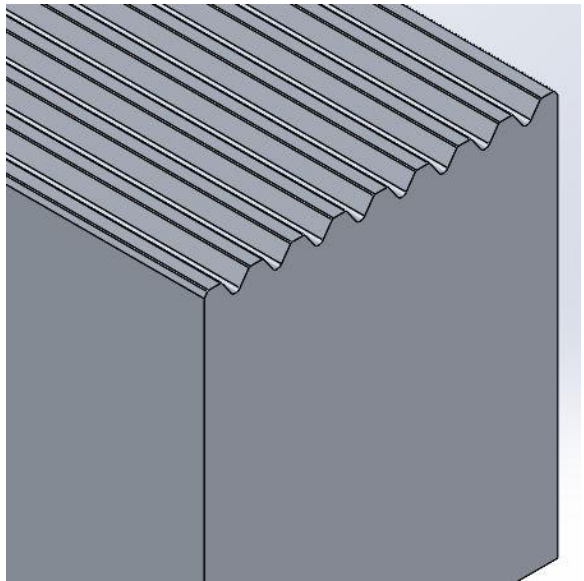
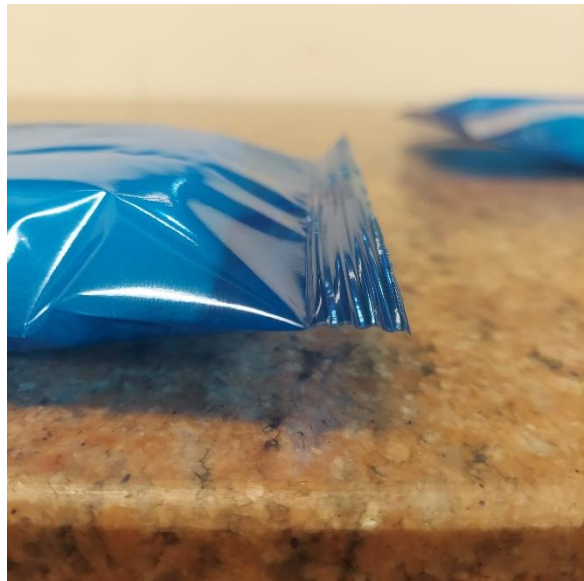
<p>Lako Seal Profile #H68</p>	<p>Package Seal – Profile #H68</p>

Lako's recommendation for this film is to use a moderately aggressive seal profile (such as Lako's H68) and high temperatures and pressures to achieve the best results.

During sealed package testing, seal profiles H181 and H68 were used along with Film 1 to create packages to be tested for hermetic seals in the Contura S400 and then tested for their ability to withstand pressure in the Pack-Vac tank. During this testing, the H181 was able to achieve a hermetic seal at lower temperatures and pressures than the H68 profile.

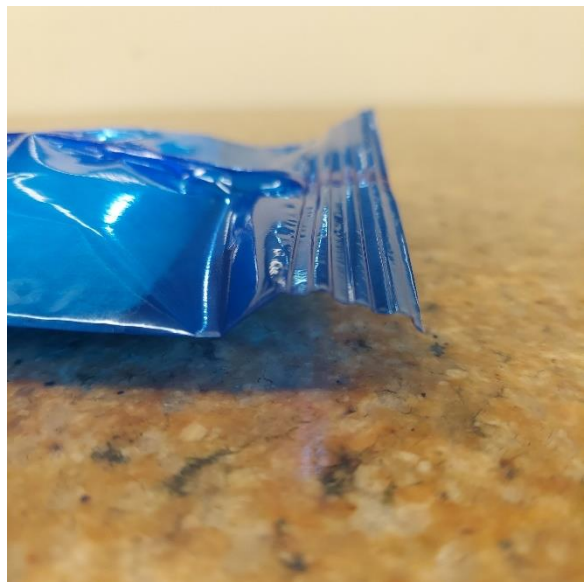
<p>Lako Seal Profile #H181</p>	<p>Package Seal – Profile #H181</p>
