SEAL STRENGTH PROFILE TESTING

**Customer
Name
1/1/2023**

Project Summary

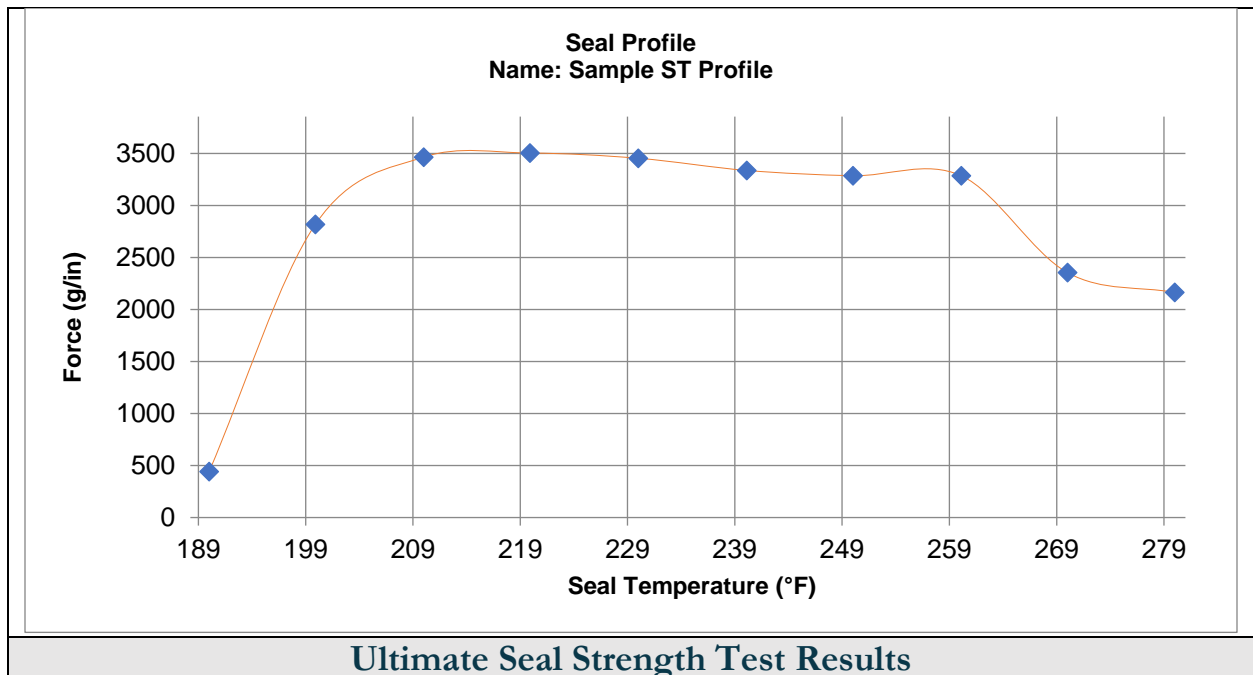
Title:	Sample Test	Name:	Est 12345 FT-01-023 Sample Test
Machine S/N:	SL10S131102	Date:	01/01/2023 12:00:00 AM
Laboratory Temp:	74°F [23.3°C]	Operator:	XXX
Laboratory Humidity:	45%	Material:	Clear Film 0.003"
Upper Starting Temp:	190.0 °F [88° C]	Lower Starting Temp:	190.0 °F [88° C]
Upper Ending Temp:	280.0 °F [138° C]	Lower Ending Temp:	280.0 °F [138° C]
Seal Length:	1.000 in	Pressure Request:	40.0 PSI
Seal Width:	0.375 in	Jaw Pattern:	Steel Upper/ Steel Lower
Dwell Time:	0.500 sec	Peel Velocity:	0.20 in/sec
Cool Delay:	20.00 sec	Selection Method:	Peak

Ultimate Seal Strength Profile Test

The tested film had the highest strength around 220 °F [104° C]. The drop-off in strength was very large as the sealing temperature was reduced below 210° F [99° C], but the strength didn't seem to drop-off much as the temperature increased until reaching 260° F [127° C].

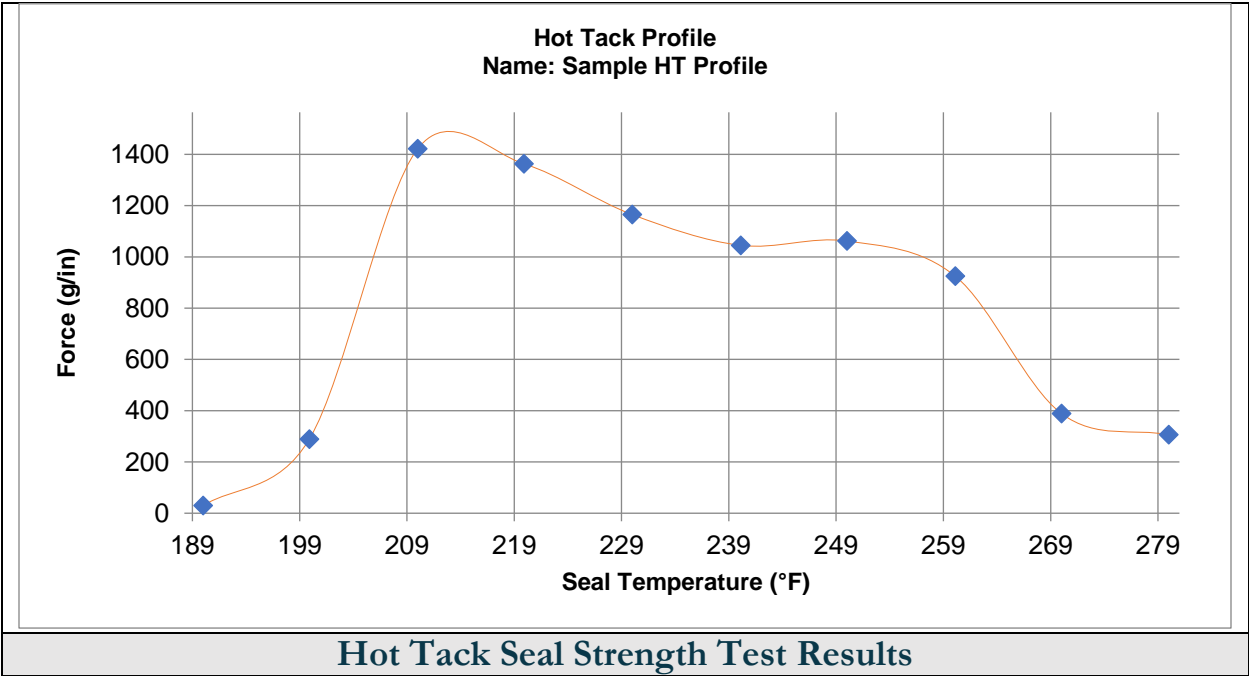
Title:	Sample Test	Name:	Est 12345 FT-01-023 Sample Test
Machine S/N:	SL10S131102	Date:	01/01/2023 12:00:00 AM
Laboratory Temp:	74°F [23.3°C]	Operator:	XXX
Laboratory Humidity:	45%	Material:	Clear Film 0.003"
Upper Starting Temp:	190.0 °F [88° C]	Lower Starting Temp:	190.0 °F [88° C]
Upper Ending Temp:	280.0 °F [138° C]	Lower Ending Temp:	280.0 °F [138° C]
Seal Length:	1.000 in	Pressure Request:	40.0 PSI
Seal Width:	0.375 in	Jaw Pattern:	Steel Upper/ Steel Lower
Dwell Time:	0.500 sec	Peel Velocity:	0.20 in/sec
Cool Delay:	Immediate	Selection Method:	Peak

Hot Tack Seal Strength Profile Test

The tested film had the highest strength around 210° F [99° C]. The drop-off in strength was very large as the sealing temperature was reduced below 210° F [99° C]. While a noticeable reduction in seal strength as sealing temperature was increased, it was not a major reduction until the seal temperature reached 260° F [127° C].

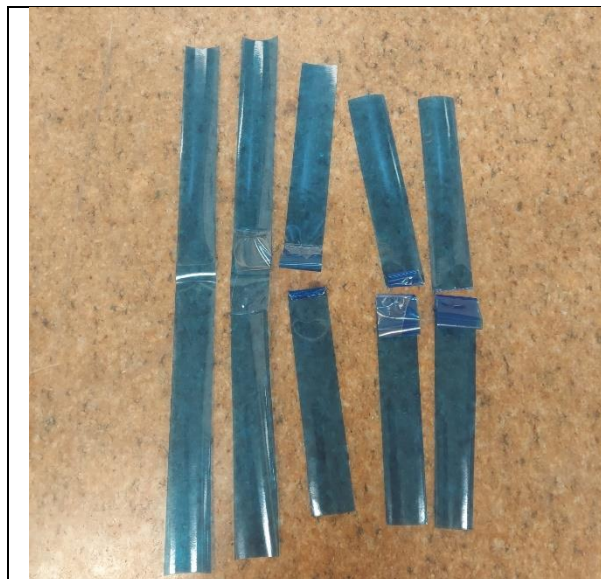
Tested Ultimate Seal Strength Samples

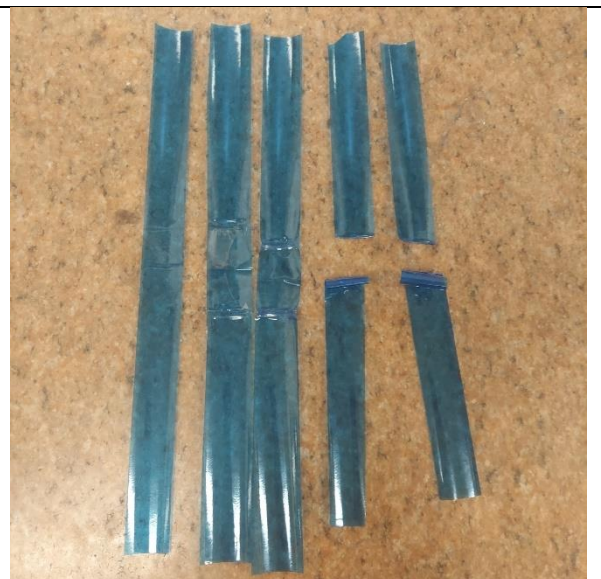
Tested Hot Tack Seal Strength Samples
