# Seal Tooth Profile Test

**Customer  
Name  
1/1/2023**

# Project Summary

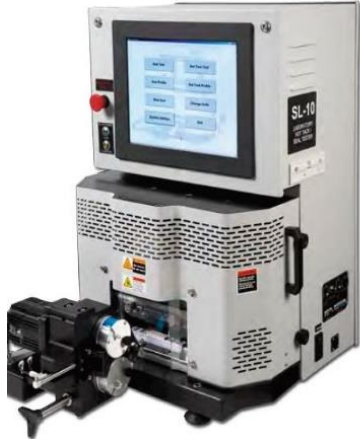
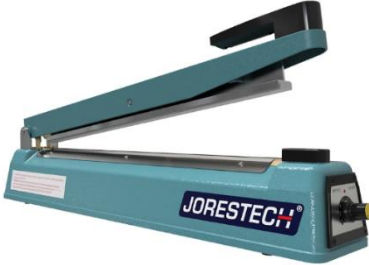
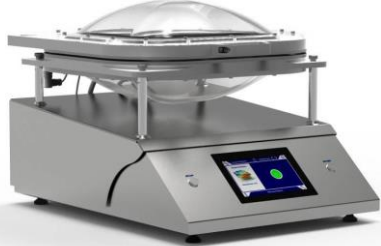
### Equipment used:

<p><b>TMI – Hot-Tack Tester and Seal Tester SL-10 75-50</b></p>	<p><b>Technopack – MS-405 Impulse Sealer</b></p>	<p><b>Inficon – Contura S400</b></p>

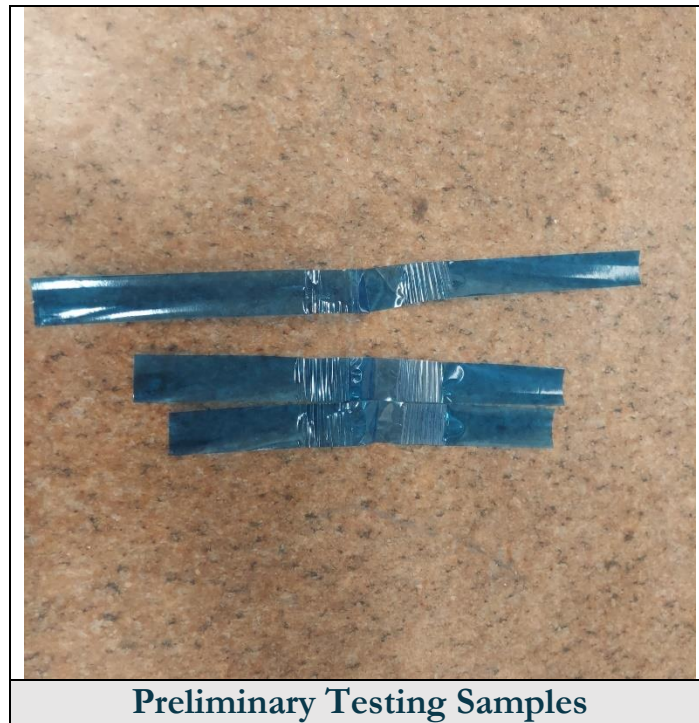
Preliminary Testing Samples

Based on observations from the preliminary testing, the recommended temperature for Seal Strength Profile Testing is **250°F** [121° C].

Material	Temperature	Observations
Film 1	200° F [93° C]	Film did not seal fully
	250° F [121° C]	Film sealed with no distortions
	300° F [149° C]	Film melted

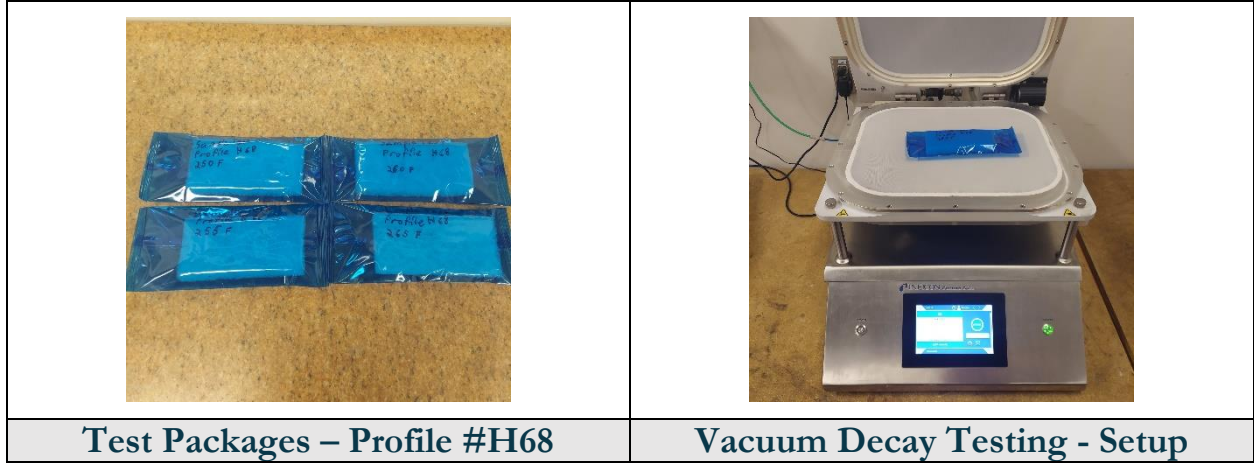
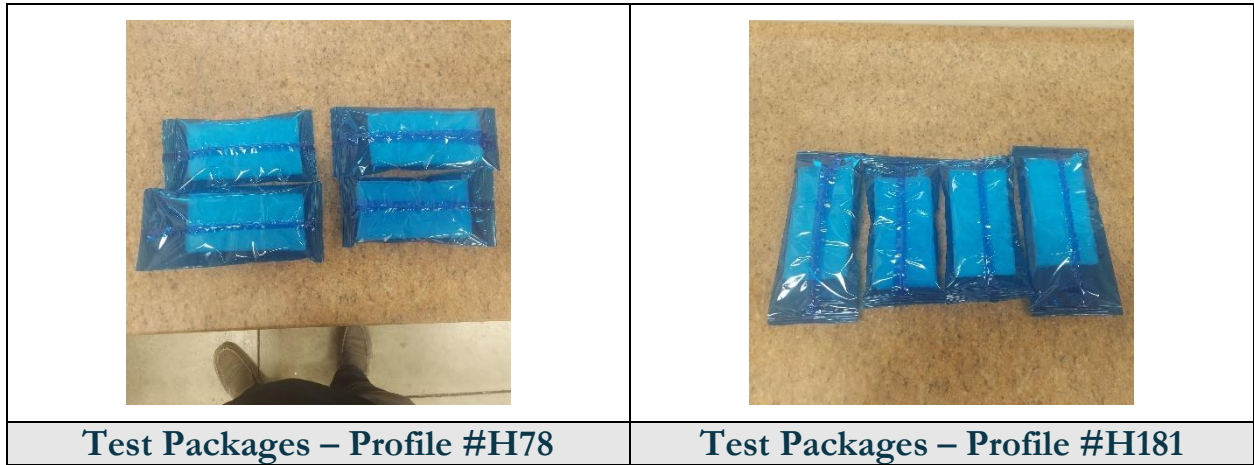
## Vacuum Decay Testing (continued)

Material	Profile #	Temp	mbar-l/s	Notes
Film #1	H68	210 °F [99° C]	0.467	None
		215 °F [102° C]	0.009	None
		220 °F [104° C]	0.010	None
		225 °F [107° C]	0.783	None
	H78	210 °F [99° C]	0.484	None
		215 °F [102° C]	0.325	None
		220 °F [104° C]	0.143	None
		225 °F [107° C]	0.628	None
	H181	210 °F [99° C]	0.452	None
		215 °F [102° C]	0.008	None
		220 °F [104° C]	0.015	None
		225 °F [107° C]	0.634	None

Profiles H68 and H181 had better leak rates than Profile H78. Each of the profiles had lower leak rates when sealed with temperatures of 215° F [102° C] and 220° F [104° C].

Recommendations based on vacuum decay testing are a seal temperature of between 215° F [102° C] and 220° F [104° C] and the seal profile # H181.
