Sealed Package Vacuum Decay Testing

Customer Name 1/1/2023

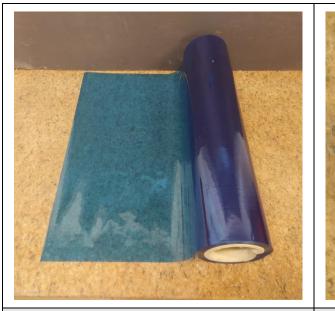
Package 1 – As Received (for reference)

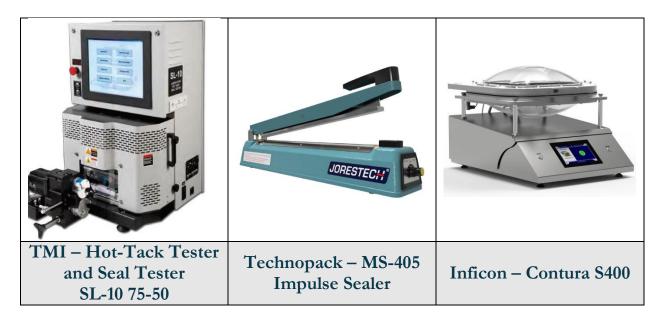
Equipment used:

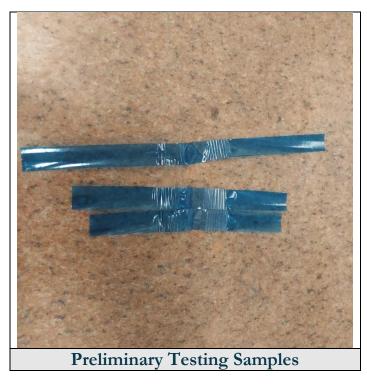
Material	Temperature	Observations	
	200° F [93° C]	Film did not seal fully	
Film 1	250° F [121° C]	Film sealed with no distortions	
	300° F [149° C]	Film melted

Based on observations from the preliminary testing, the recommended temperature for Seal Strength Profile Testing is **250°F** [121° C].

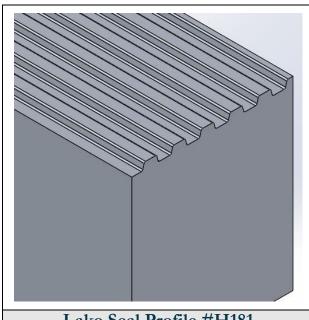
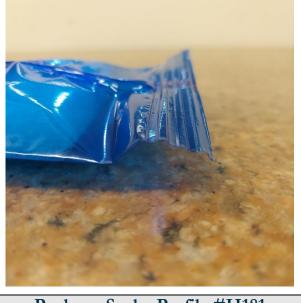
Lako Seal Profile #H181

Package Seal – Profile #H181

Recommendations based on vacuum decay testing are a seal temperature of between 215° F [102° C] and 220° F [104° C] and the seal profile # H181.
