Sealed Package Integrity Test

Project Summary

Project Details

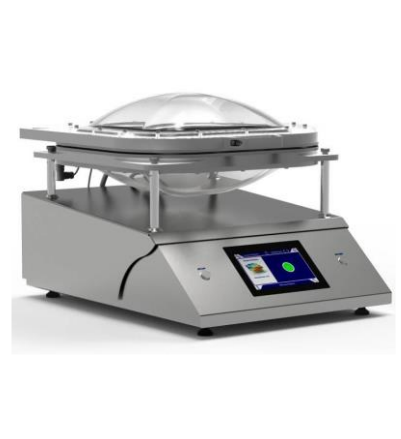
Equipment used:

TMI – Hot-Tack Tester and Seal Tester SL-10 75-50	Technopack – MS-405 Impulse Sealer	Inficon – Contura S400

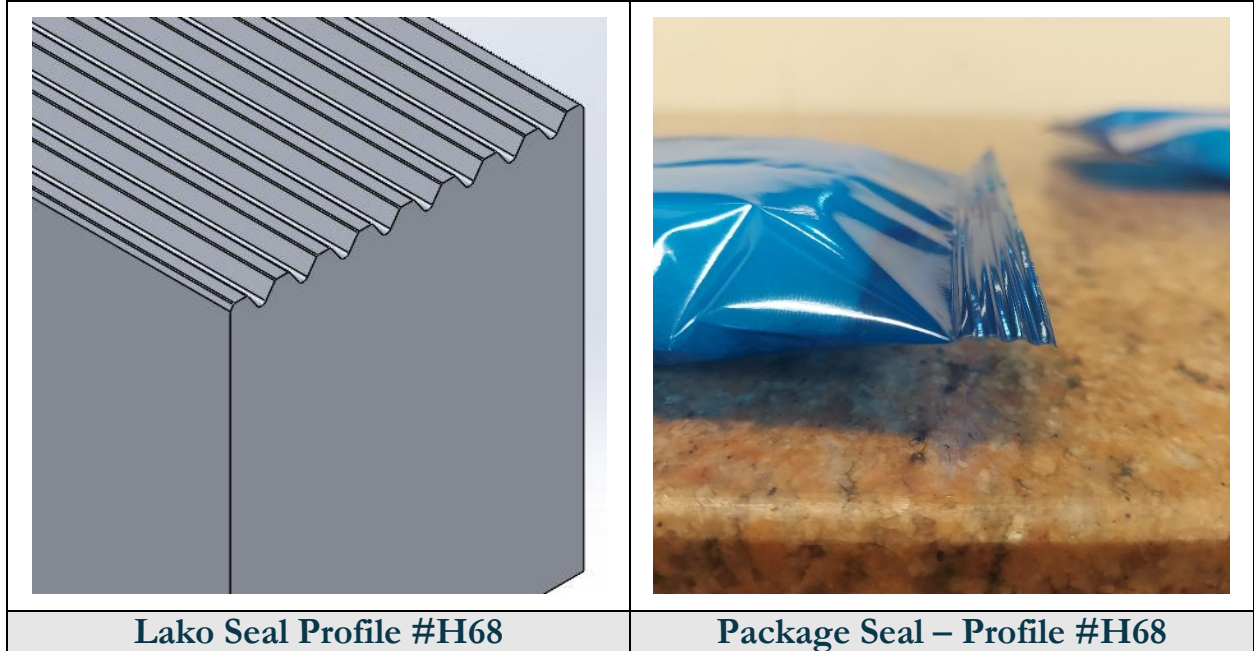
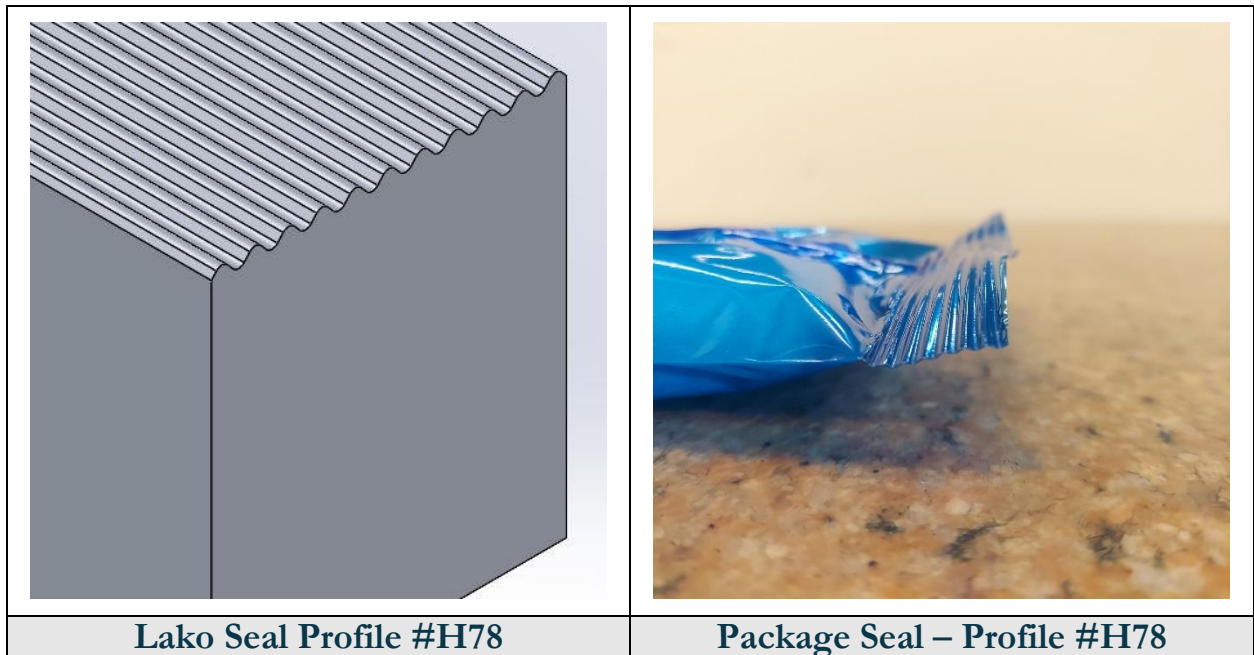
Seal Tooth Profile Examples

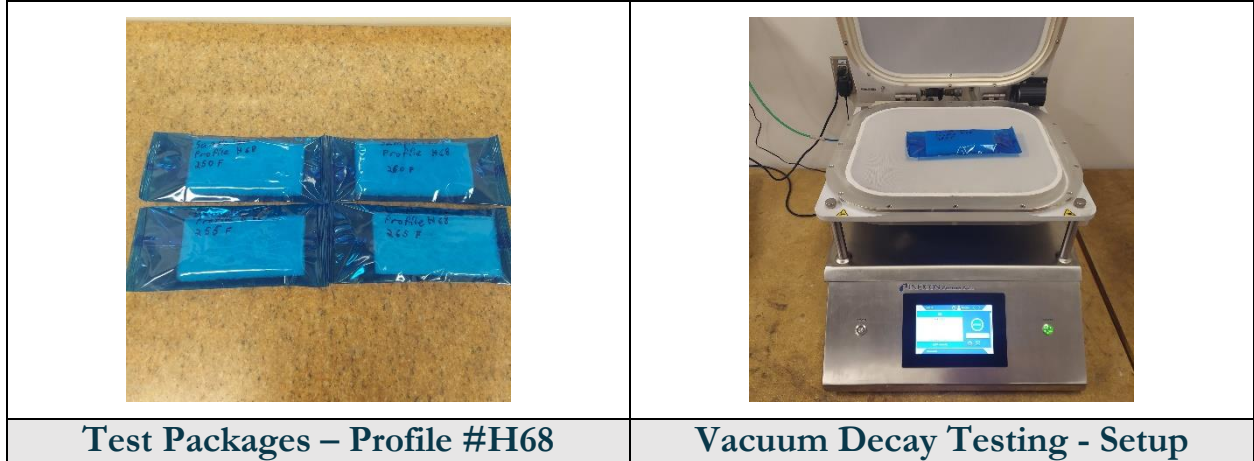
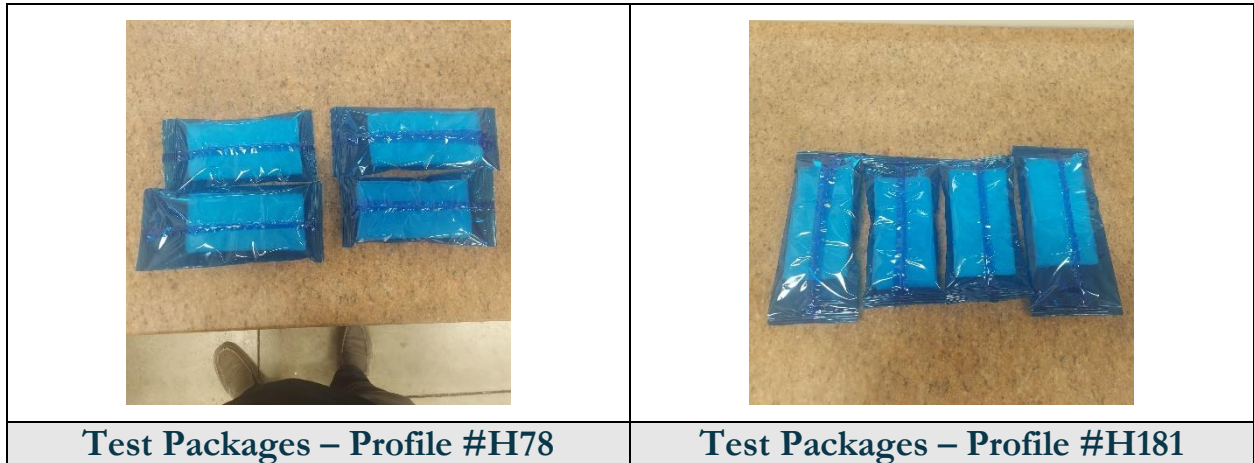
Vacuum Decay Testing (continued)

Material	Profile #	Temp	mbar-l/s	Notes
Film #1	H68	210 °F [99° C]	0.467	None
		215 °F [102° C]	0.009	None
		220 °F [104° C]	0.010	None
		225 °F [107° C]	0.783	None
	H78	210 °F [99° C]	0.484	None
		215 °F [102° C]	0.325	None
		220 °F [104° C]	0.143	None
		225 °F [107° C]	0.628	None
	H181	210 °F [99° C]	0.452	None
		215 °F [102° C]	0.008	None
		220 °F [104° C]	0.015	None
		225 °F [107° C]	0.634	None

Profiles H68 and H181 had better leak rates than Profile H78. Each of the profiles had lower leak rates when sealed with temperatures of 215° F [102° C] and 220° F [104° C].

Recommendations based on vacuum decay testing are a seal temperature of between 215° F [102° C] and 220° F [104° C] and the seal profile # H181.
