# Seal Strength and Sealed Package Testing

**Customer  
Name  
1/1/2023**

# Project Summary

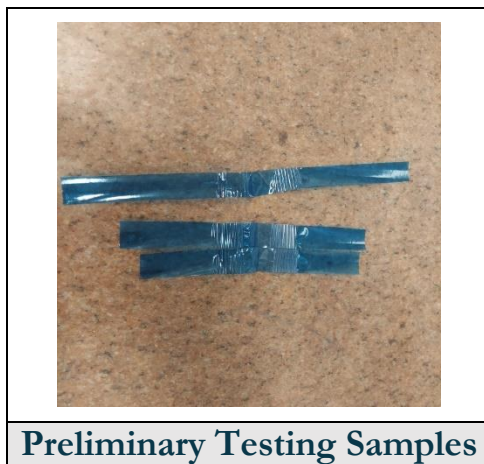
Material	Temperature	Observations
Film 1	200° F [93° C]	Film did not seal fully
	250° F [121° C]	Film sealed with no distortions
	300° F [149° C]	Film melted

Preliminary Testing Samples

Based on observations from the preliminary testing, the recommended temperature range for Seal Strength Profile Testing is **190° F to 280° F** [88° C to 138° C].

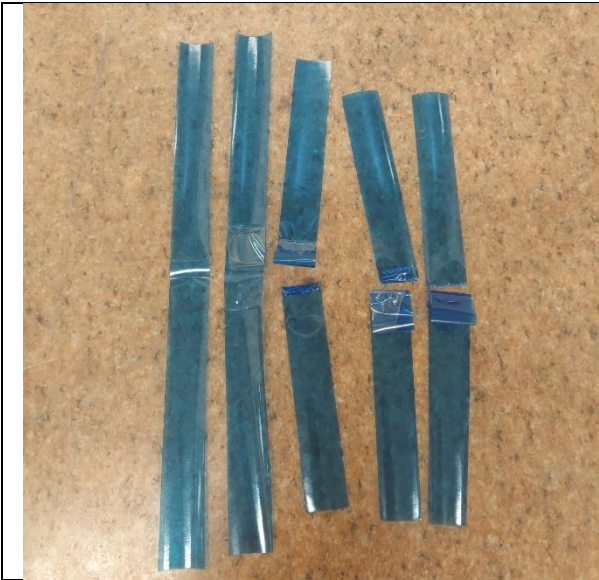
**Tested Ultimate Seal Strength Samples**

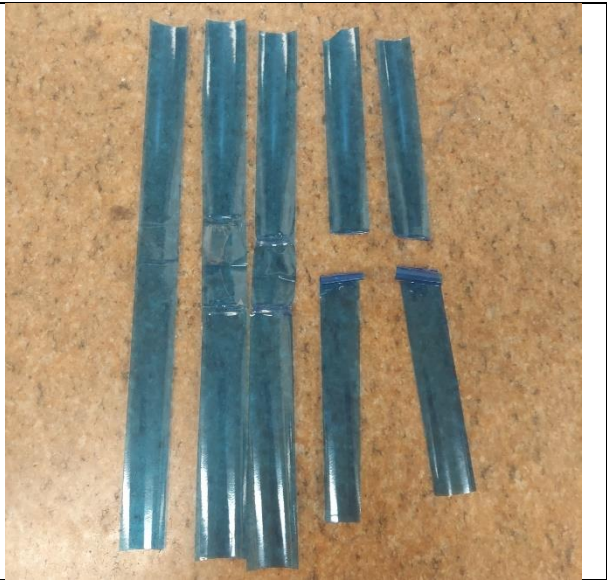
**Tested Hot Tack Seal Strength Samples**

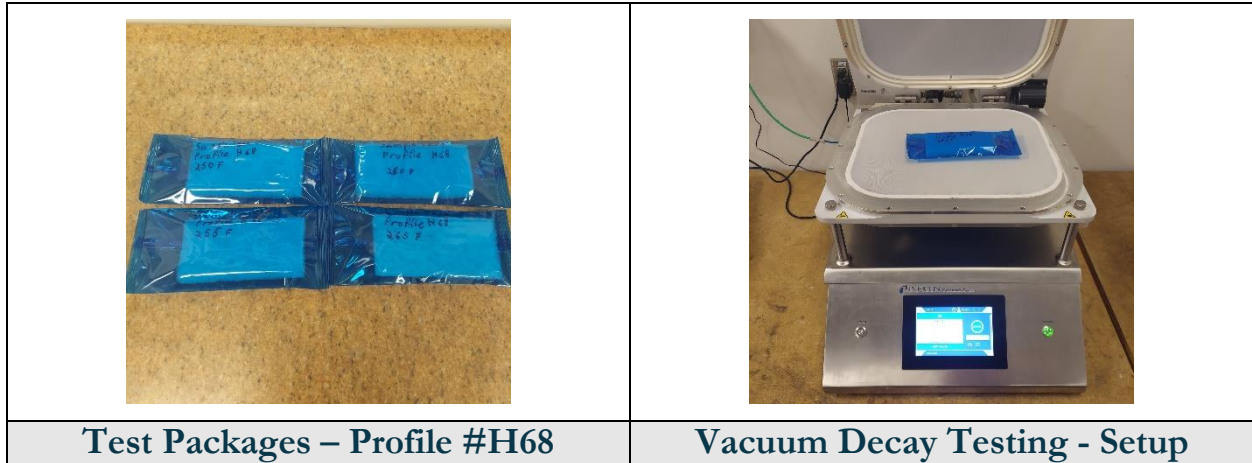
## Vacuum Decay Testing (continued)

During sealed package testing, seal profiles H181 and H68 were used along with Film 1 to create packages to be tested for hermetic seals in the Contura S400 and then tested for their ability to withstand pressure in the Pack-Vac tank. During this testing, the H181 was able to achieve a hermetic seal at lower temperatures and pressures than the H68 profile.

Most of the tested packages had a leak rate around 1 mbar·L/s, and none of them were below the target leak rate. The results did not conclusively indicate that the leak rate was significantly impacted by seal temperature.
