Seal Strength Profile Testing

**Customer
Name
1/1/2023**

Project Summary

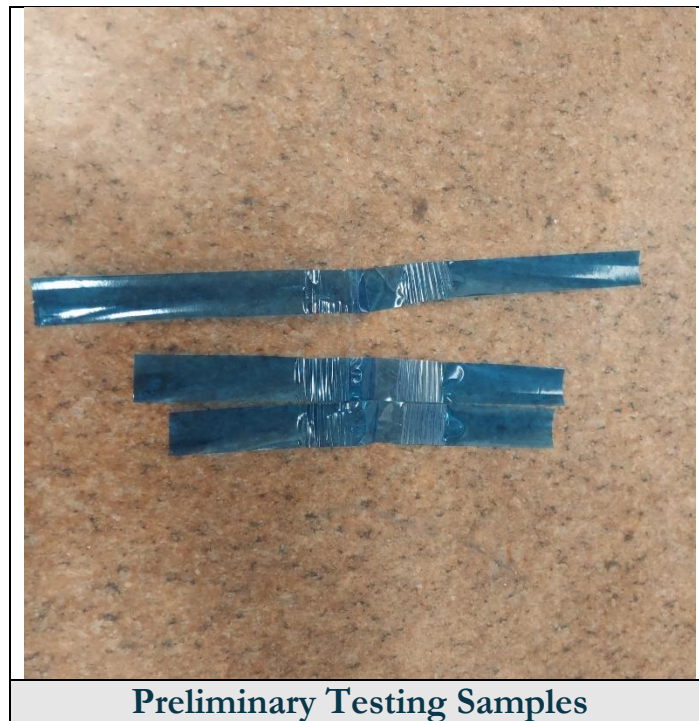
Material	Temperature	Observations
Film 1	200° F [93° C]	Film did not seal fully
	250° F [121° C]	Film sealed with no distortions
	300° F [149° C]	Film melted

Based on observations from the preliminary testing, the recommended temperature range for Seal Strength Profile Testing is **190° F to 280° F** [88° C to 138° C].

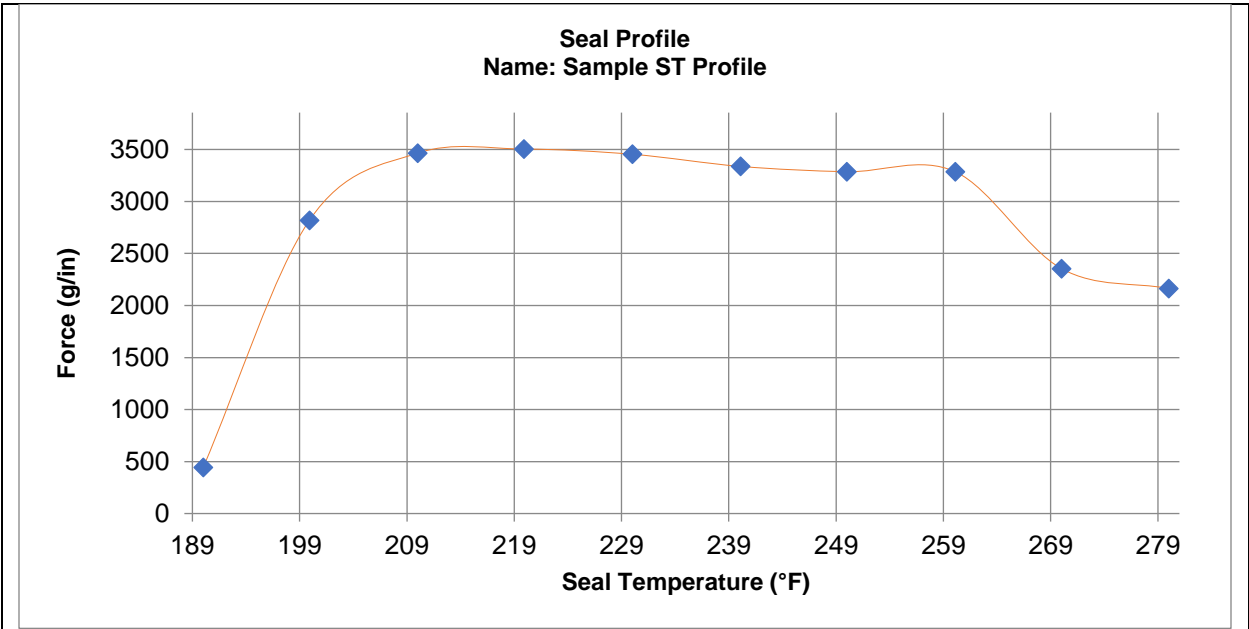
Ultimate Seal Strength Test Results

Title:	Sample Test	Name:	Est 12345 FT-01-023 Sample Test
Machine S/N:	SL10S131102	Date:	01/01/2023 12:00:00 AM
Laboratory Temp:	74°F [23.3°C]	Operator:	XXX
Laboratory Humidity:	45%	Material:	Clear Film 0.003"
Upper Starting Temp:	190.0 °F [88° C]	Lower Starting Temp:	190.0 °F [88° C]
Upper Ending Temp:	280.0 °F [138° C]	Lower Ending Temp:	280.0 °F [138° C]
Seal Length:	1.000 in	Pressure Request:	40.0 PSI
Seal Width:	0.375 in	Jaw Pattern:	Steel Upper/ Steel Lower
Dwell Time:	0.500 sec	Peel Velocity:	0.20 in/sec
Cool Delay:	20.00 sec	Selection Method:	Peak

The tested film had the highest strength around 220 °F [104° C]. The drop-off in strength was very large as the sealing temperature was reduced below 210° F [99° C], but the strength didn't seem to drop-off much as the temperature increased until reaching 260° F [127° C].

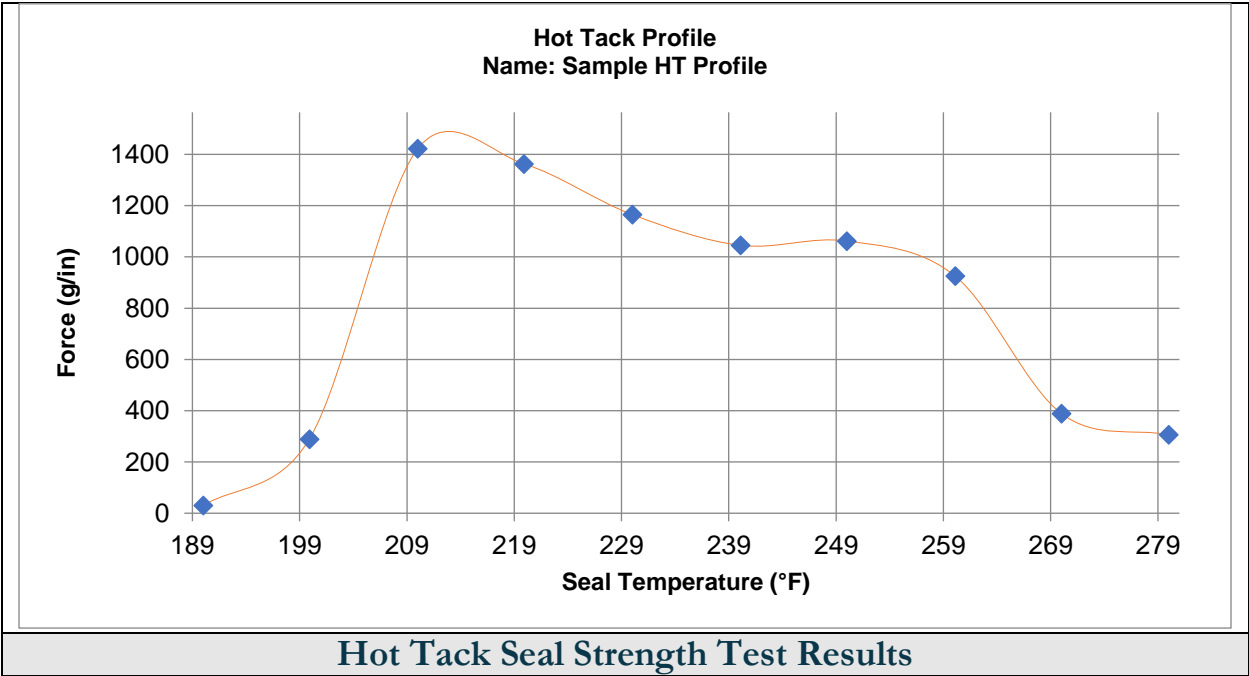
Title:	Sample Test	Name:	Est 12345 FT-01-023 Sample Test
Machine S/N:	SL10S131102	Date:	01/01/2023 12:00:00 AM
Laboratory Temp:	74°F [23.3°C]	Operator:	XXX
Laboratory Humidity:	45%	Material:	Clear Film 0.003"
Upper Starting Temp:	190.0 °F [88° C]	Lower Starting Temp:	190.0 °F [88° C]
Upper Ending Temp:	280.0 °F [138° C]	Lower Ending Temp:	280.0 °F [138° C]
Seal Length:	1.000 in	Pressure Request:	40.0 PSI
Seal Width:	0.375 in	Jaw Pattern:	Steel Upper/ Steel Lower
Dwell Time:	0.500 sec	Peel Velocity:	0.20 in/sec
Cool Delay:	Immediate	Selection Method:	Peak

The tested film had the highest strength around 210° F [99° C]. The drop-off in strength was very large as the sealing temperature was reduced below 210° F [99° C]. While a noticeable reduction in seal strength as sealing temperature was increased, it was not a major reduction until the seal temperature reached 260° F [127° C].
